Choctaw Nation of Oklahoma

UST Facility
Regulatory
Management

Working together to improve regulatory compliance and value to Choctaw Travel Plaza operation

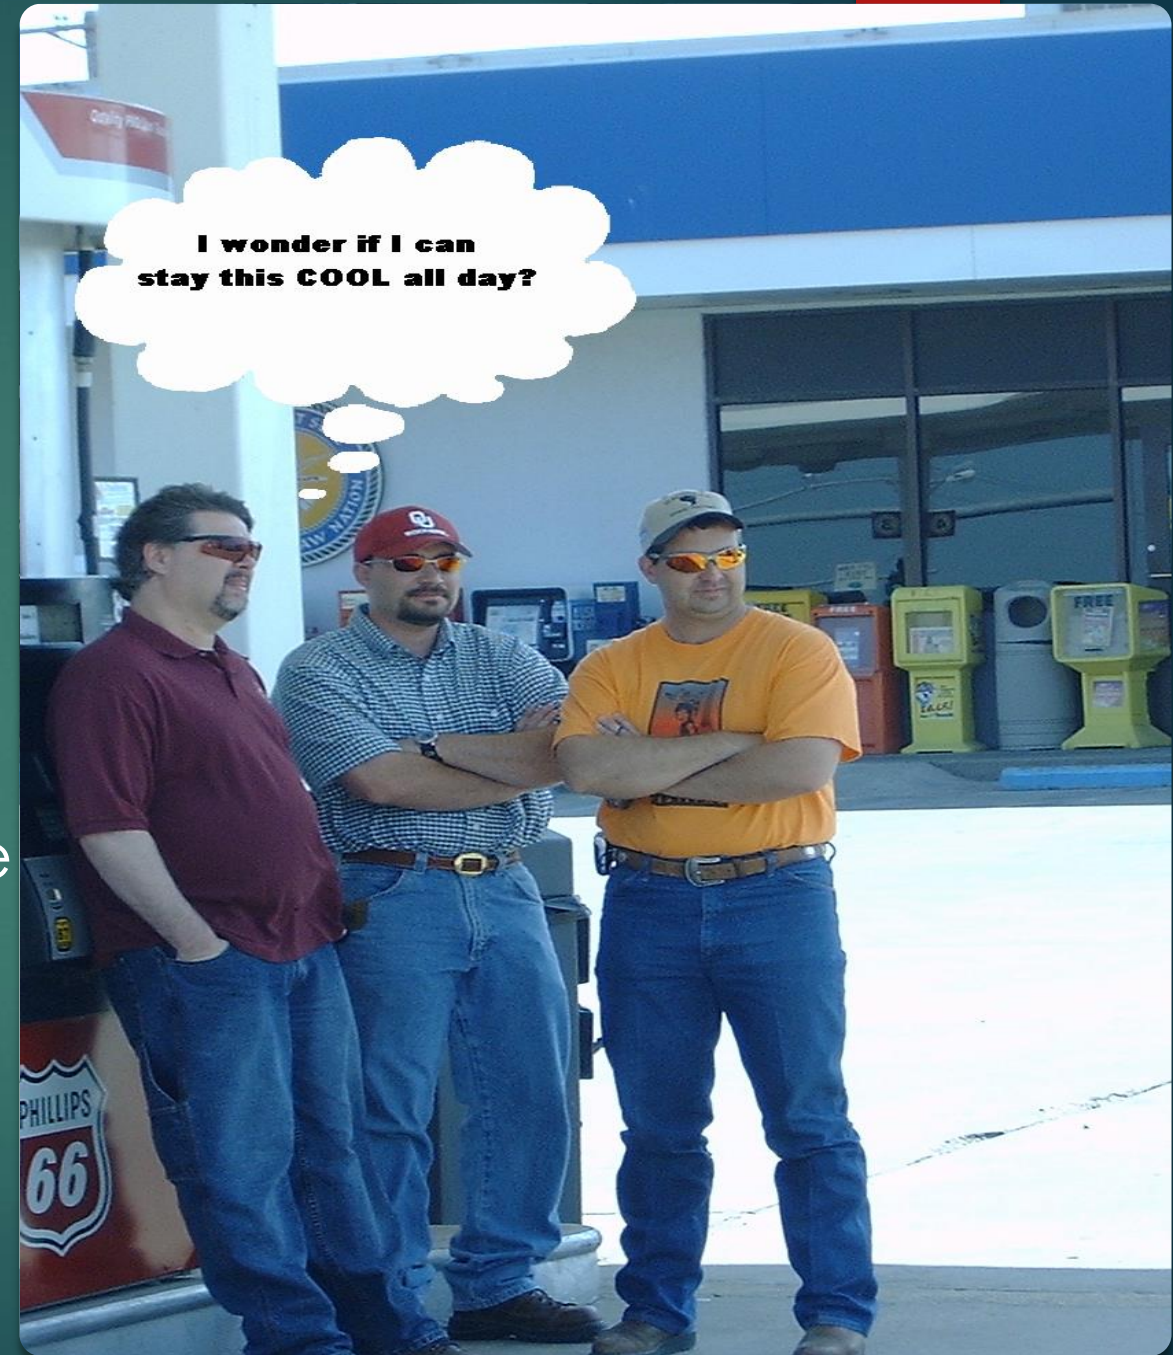
May, 2005

Picture taken at Durant #1 site where site
assessment was taking place to identify
old release from piping change.

No significant contamination was found.

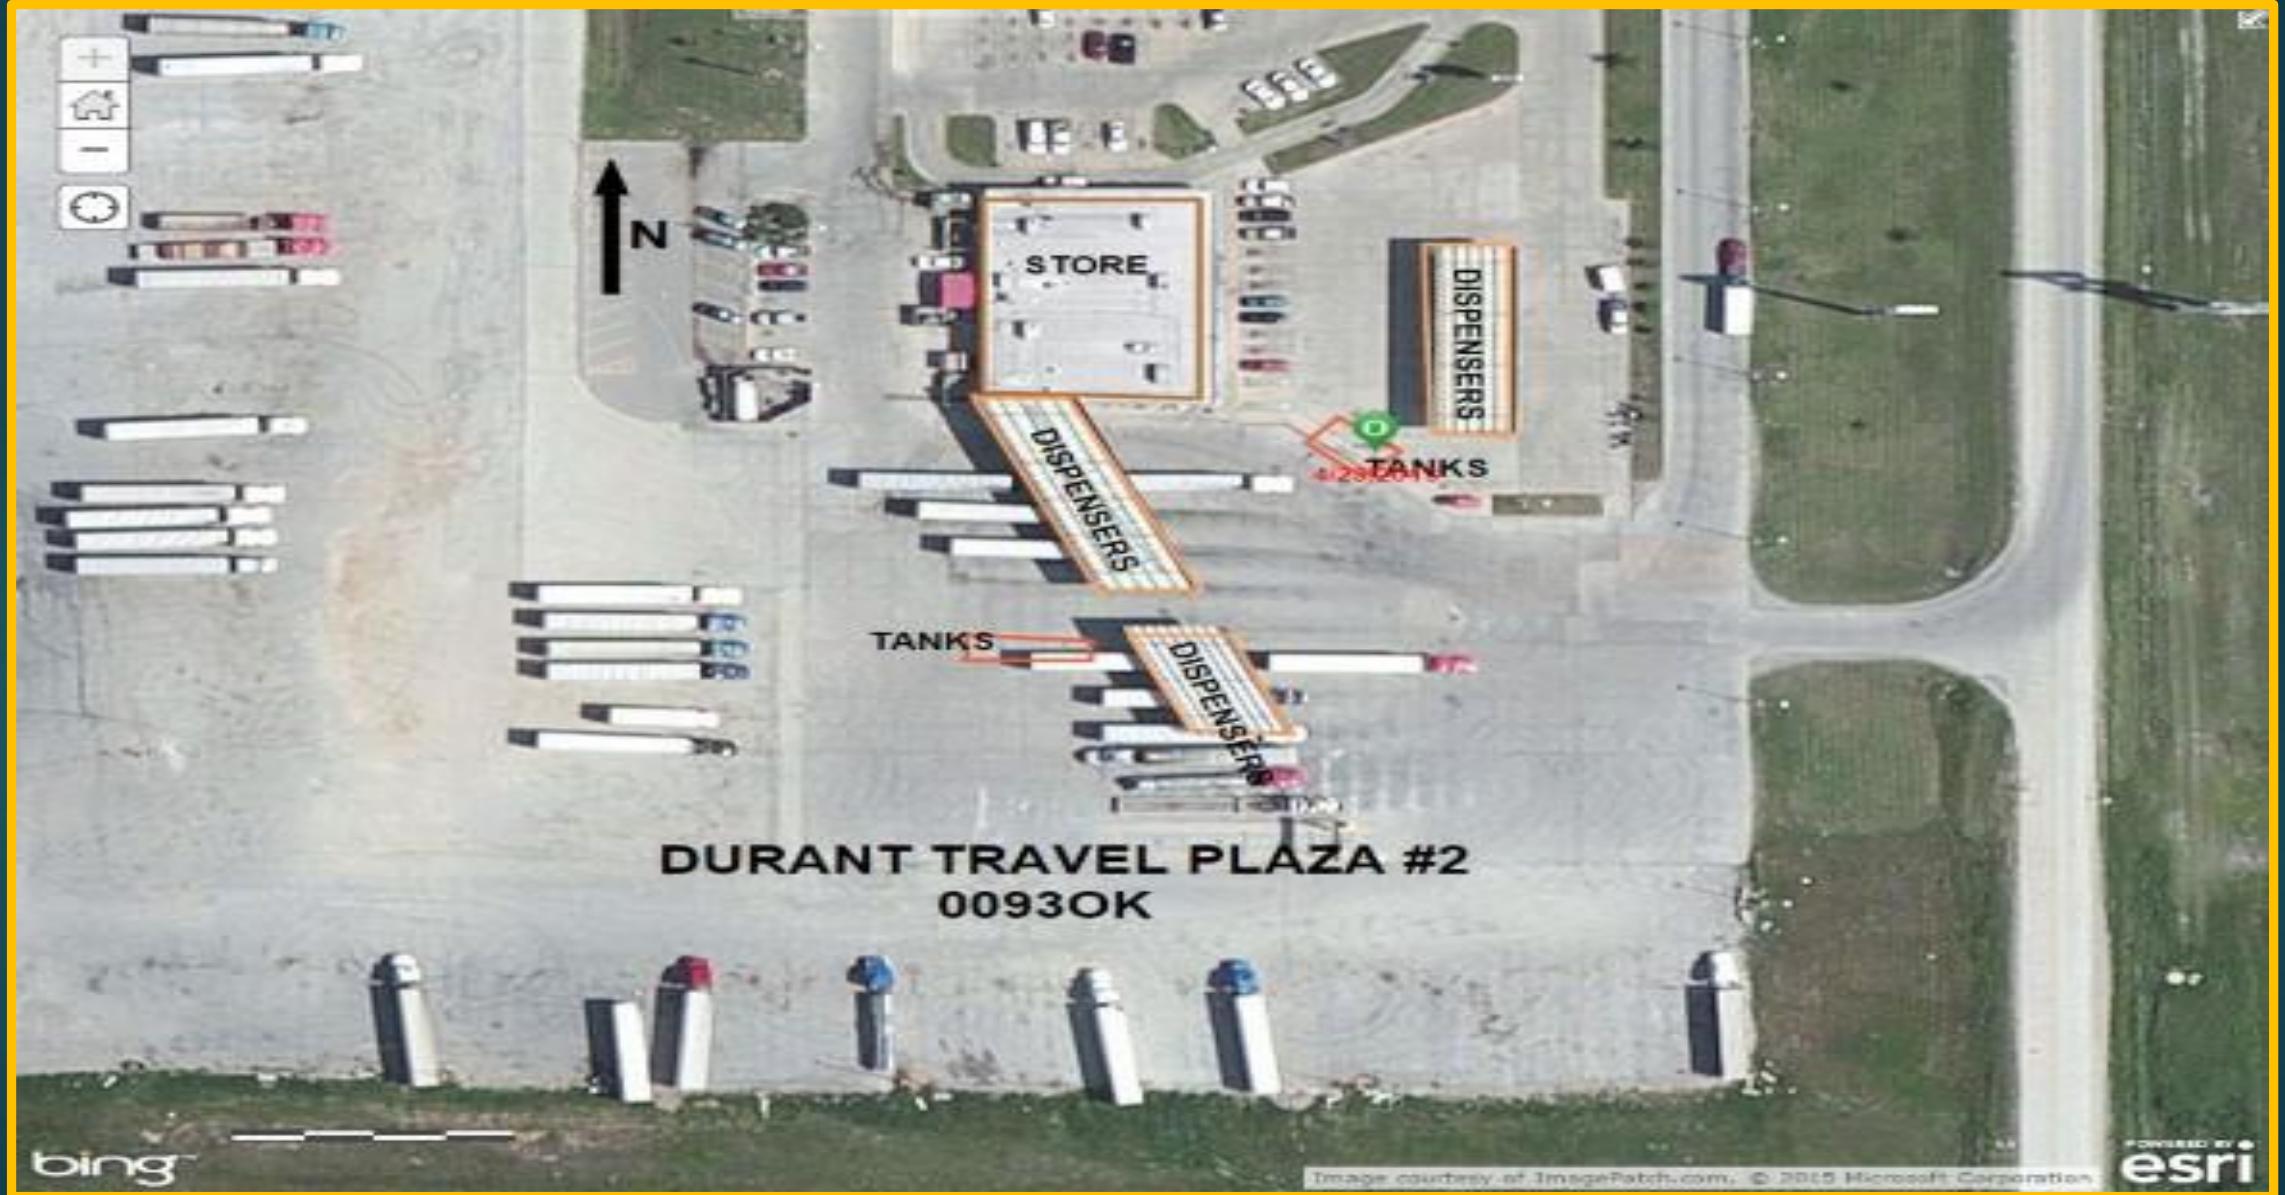
Durant Travel Plaza #2

- ▶ The system at this large truck stop type Travel Plaza consists of 5 tanks. Some tanks are single wall composite steel tanks while the newer diesel tanks are double wall composite steel tanks.
- ▶ All piping is fiberglass reinforced plastic.
- ▶ The Durant facility has a capacity for 50,000 gallons diesel and 22,000 gallons of gasoline.

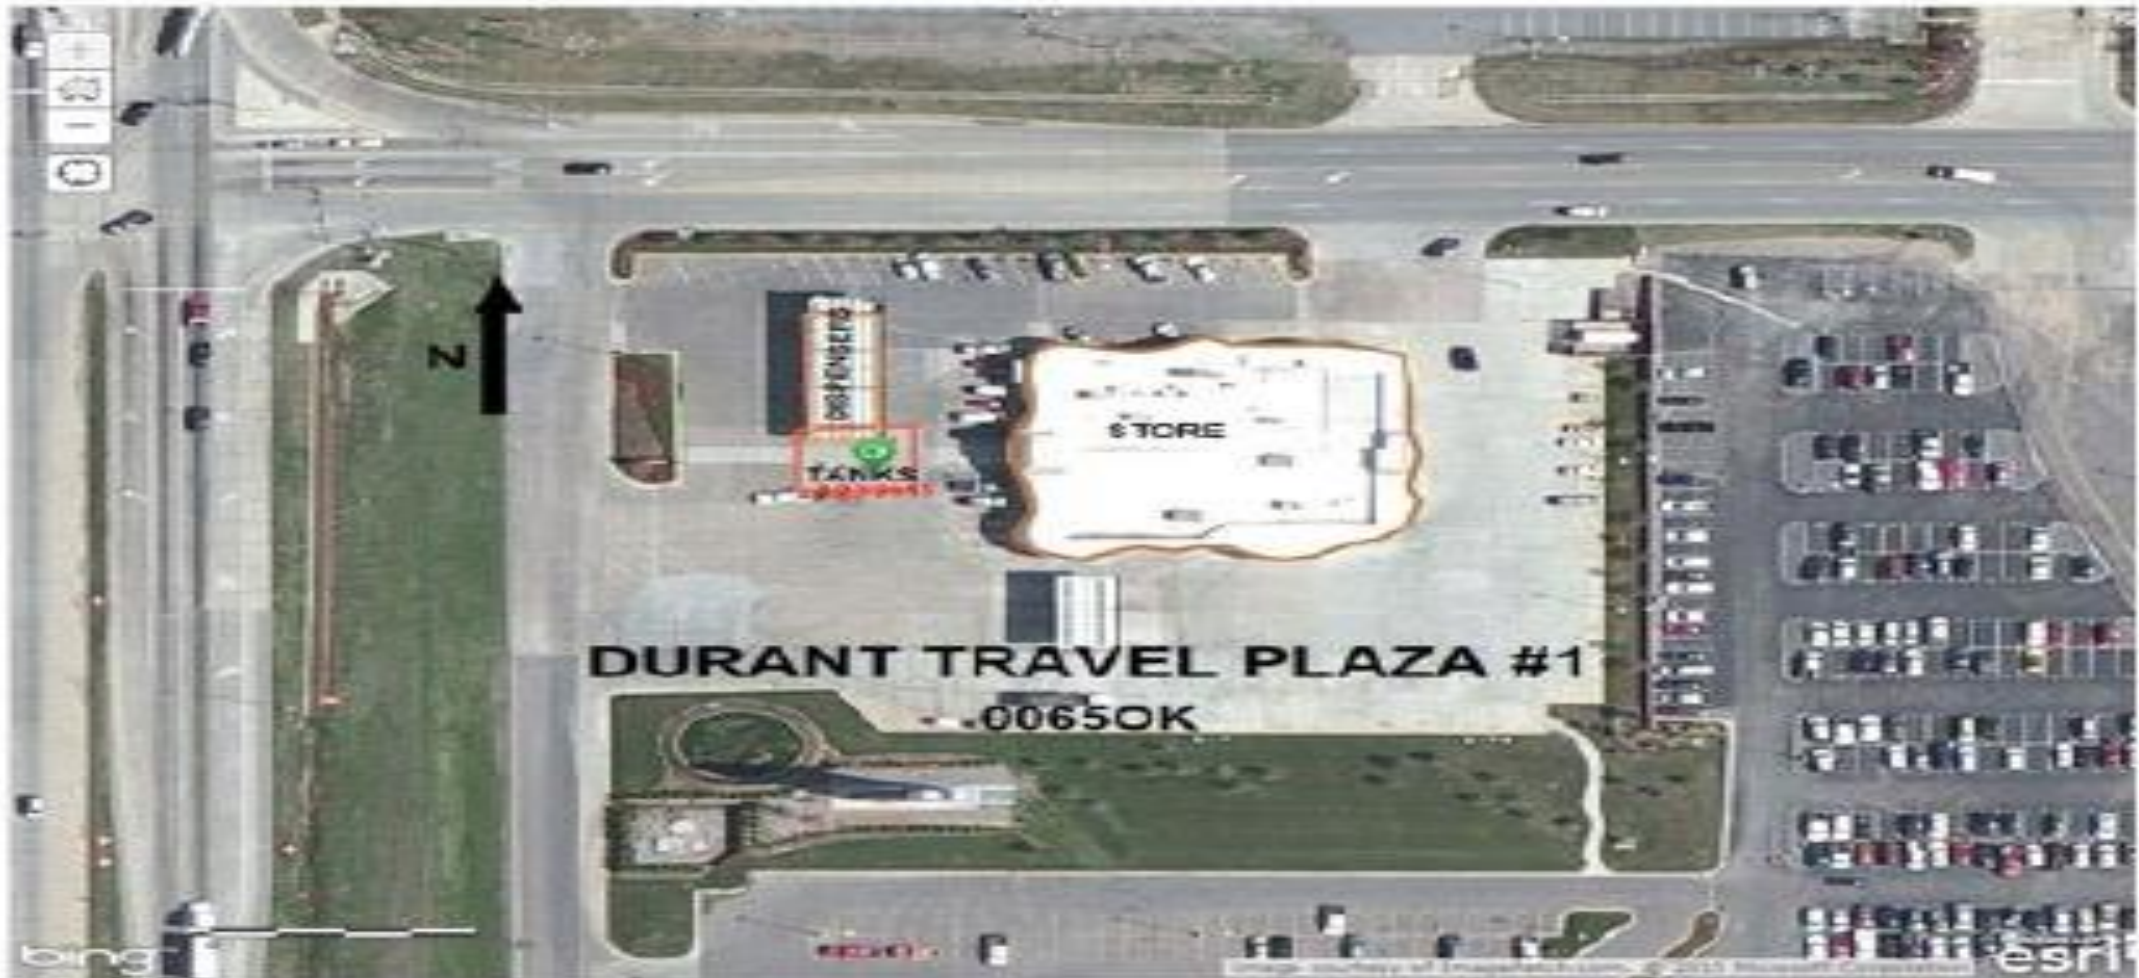
FIGURE 1 – SITE FIGURE

Facility Layout as Presented in Report

CHOCTAW TRAVEL PLAZA DURANT #1 0065OK

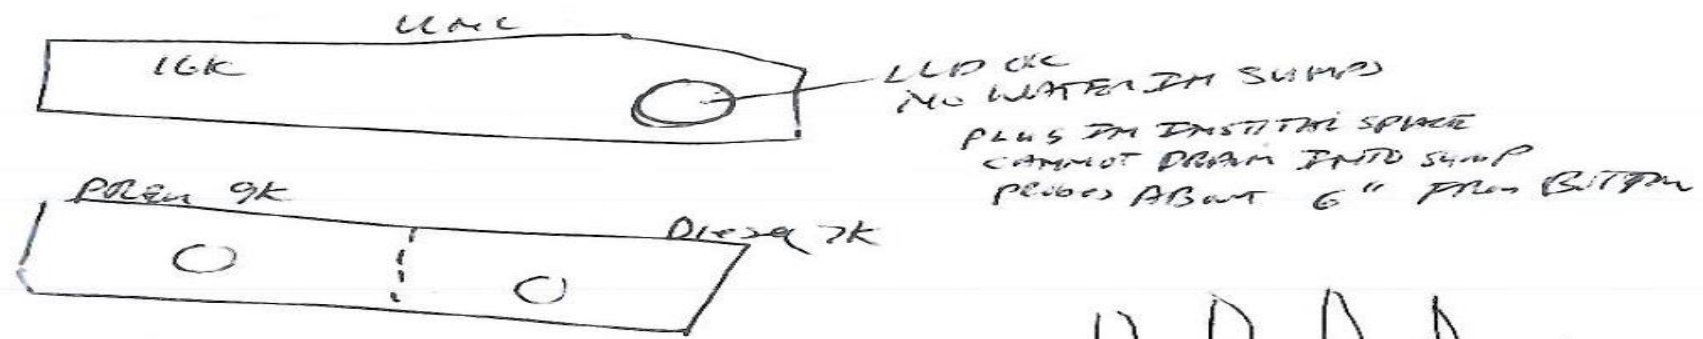
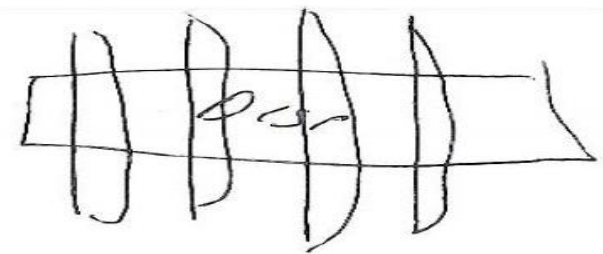
SITE DRAWING

LLD'S IMPULSER (ELECTRONIC)
 ALL PUMP SUMPS WERE DRY
 THE INSTANT PIPING WAS BLOCKED
 IN ALL THREE SUMPS BY A BOLT
 IF THERE WAS A LEAK IN THE
 PLEX PIPING (DOUBLE WAVE) IT WOULD
 NOT DRAIN INTO PUMP SUMPS TO BE PICKED UP BY PROBES IN SUMPS
 HOWEVER USING PLEX. LLD'S ~~WAS~~ WHICH
 TEST PIPING

PROBES IN SUMPS SHOULD BE LOWERED CLOSER TO BOTTOM
 OF SUMPS.
~~SUMP SENSORS DO NOT APPEAR TO BE CONNECTED TO APL SYSTEM~~
 (OUL SUMP SENSORS NEARLY BE CHECKED TO SEE IF WORKING)
VIOLATION
 NOT KEEPING MONTHLY RECORDS ON TANKS LINES
 UNCLE TOMAS TANK & PIPING DID NOT ~~PROBE~~ TEST IN LAST 12 MONTHS.

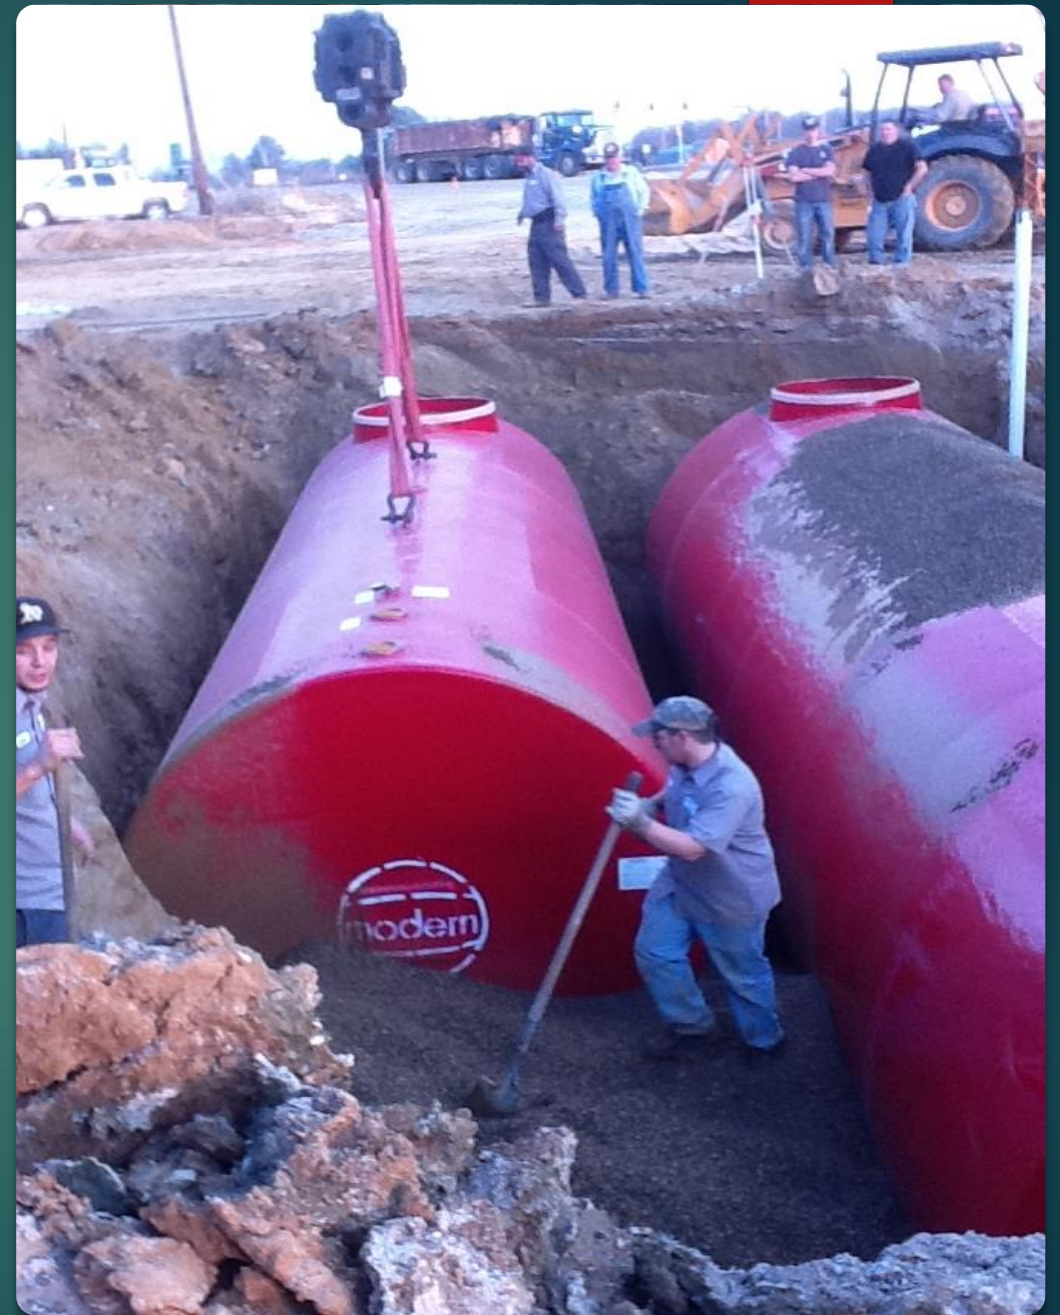
New state of the art double wall, steel tanks

These tanks were installed at the Idabel Oklahoma facility as part of upgrade of the Travel Plazas. The old facility, which was located across the street, was closed and the old tanks removed.
