Ground-water surface-water interactions and long-term change in riverine riparian vegetation in the southwestern United States

Robert H. Webb*, Stanley A. Leake

U.S. Geological Survey, 520 N. Park Avenue, Tucson, AZ 85745, USA

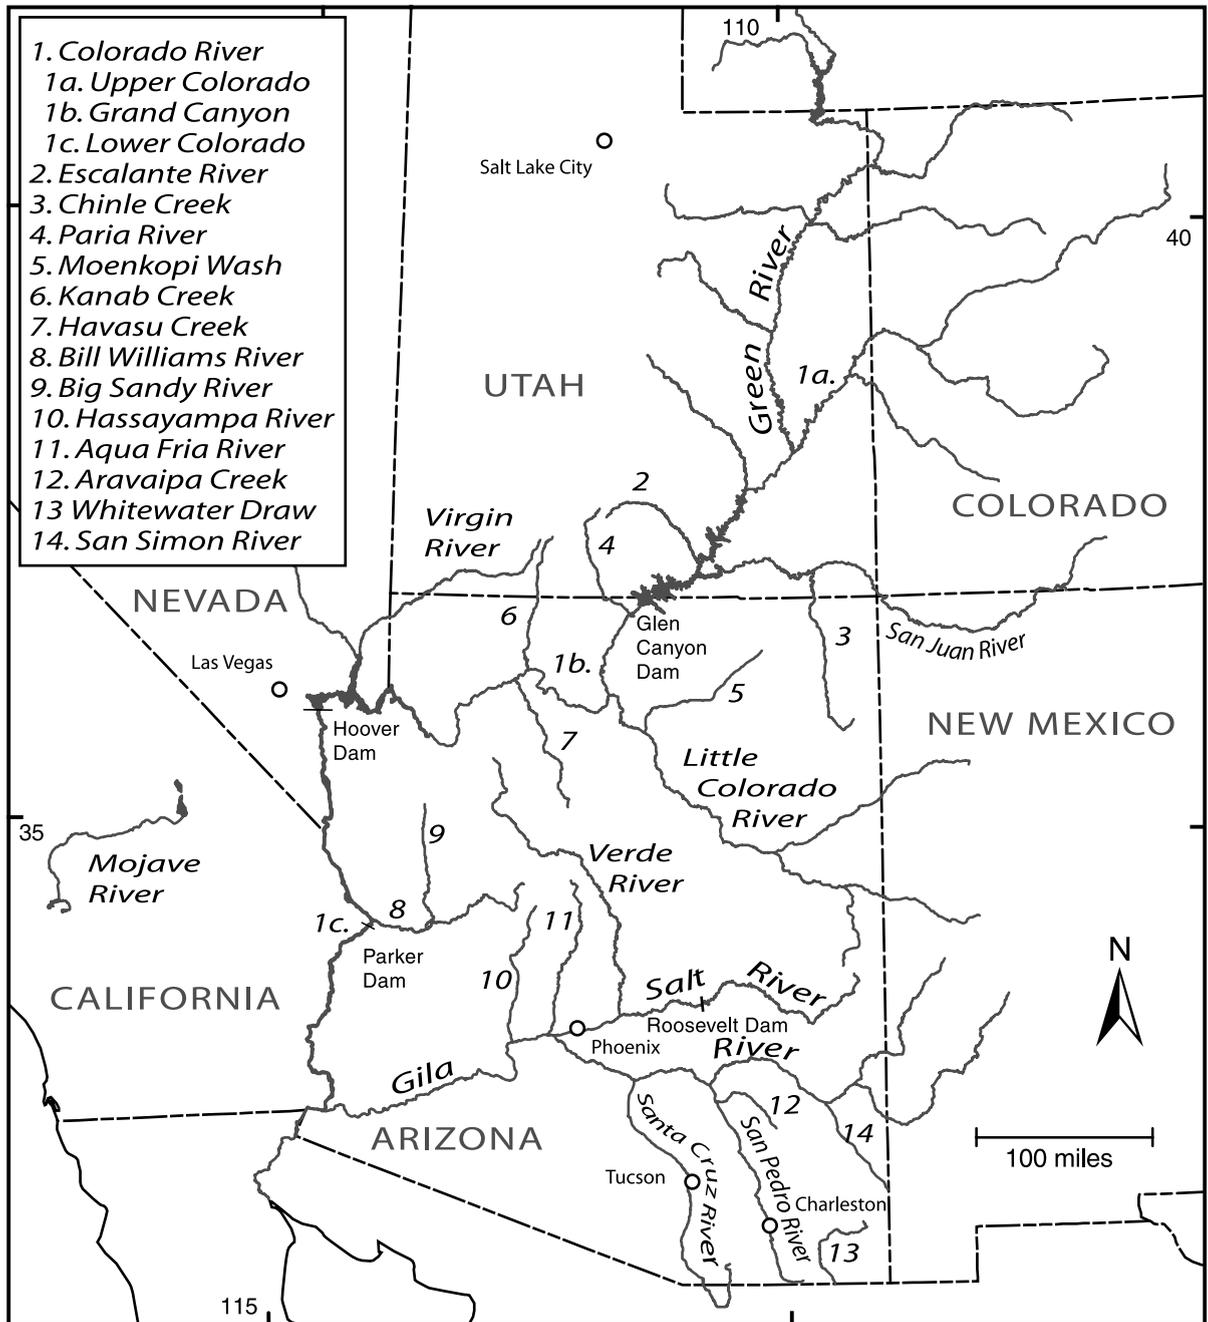
Fig. 1. Map of the southwestern United States showing river reaches used to analyze regional change in riparian vegetation.

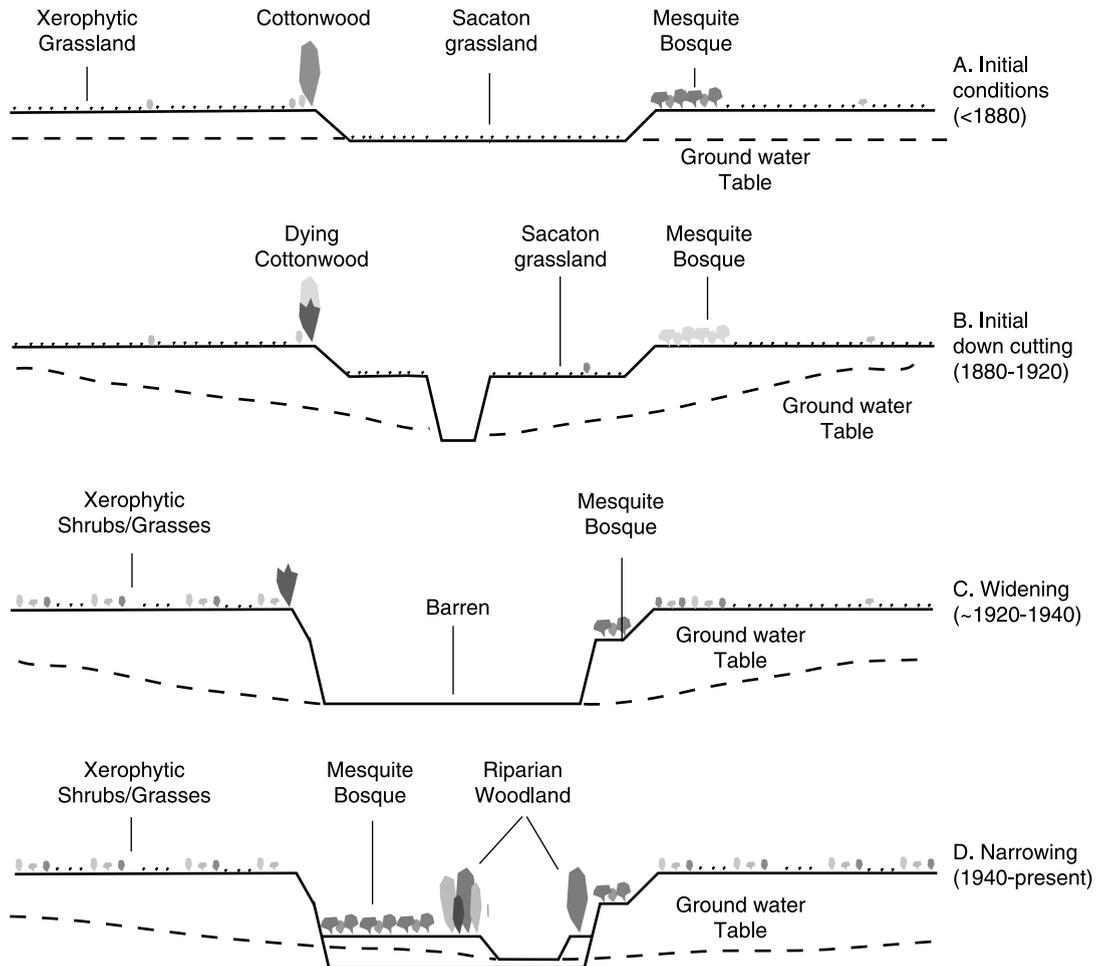
Fig. 2. Diagram showing a generalized response of riparian vegetation to the process of arroyo downcutting and widening of alluvial channels from about 1880 to the present.

Channel changes on the San Pedro River closely follow the conceptual model of arroyo downcutting depicted in Fig. 2. Beginning in the late 1870 s, floods in the San Pedro River began downcutting, creating a well-developed arroyo near the confluence with the Gila River by 1883. This headcut had extended 200 km upstream into the upper San Pedro River by

As with the San Pedro River, channel change along the Santa Cruz River follows the conceptual model depicted in Fig. 2. Beginning about 1878, the Santa Cruz River downcut into its flood plain in the vicinity of Tucson, and the headcut propagated upstream (Betancourt, 1990). The downcutting and subsequent widening occurred during a series of floods, with substantial erosion occurring between 1878 and 1891. A large flood in 1916, at the start of the gaging record (Fig. 10B), widened the channel, destroying bridges in the City of Tucson. Photographs taken during the period of arroyo entrenchment document recovery of riparian vegetation, with new cottonwood stands and mesquite bosques forming adjacent to the active channel.

At some unknown time, but probably extending through the 1930 s, the arroyo coalesced into a continuously incised channel from Tucson to the headwaters. Photographs of the river taken in 1942 from Martinez Hill, upstream of Tucson (Fig. 7), show a shallowly incised channel through a corridor of cottonwood trees in a wide mesquite bosque (Fig. 11A). At that time, the bosque was highly valued as White-wing Dove habitat by the Arizona Game and Fish Department, and ground-water development was believed to threaten this habitat. Floods in the middle part of the 20th century were generally small and caused by summer thunderstorms (Webb and Betancourt, 1992). Nineteenth century agricultural activities near Tucson were sustained by surface-water diversion (Betancourt, 1990), which ceased owing to the combination of arroyo downcutting and the mid-century drought. Ground-water development accelerated in the 1950 s, leading to significant lowering of the water table in the alluvial aquifer by the 1970 s (Fig. 10A). By the 1970 s, the riparian vegetation and mesquite bosques had been eliminated, which deviates from the conceptual model depicted in Fig. 2.

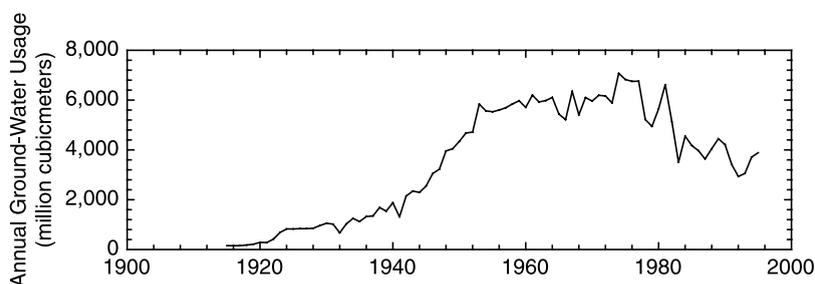
Fig. 3. Total ground-water withdrawals in Arizona, 1915–1995. (Data for 1915–1990 from Anning and Duet, (1994); data for 1991–1995 from M.T. Anderson, unpublished data, 2003).

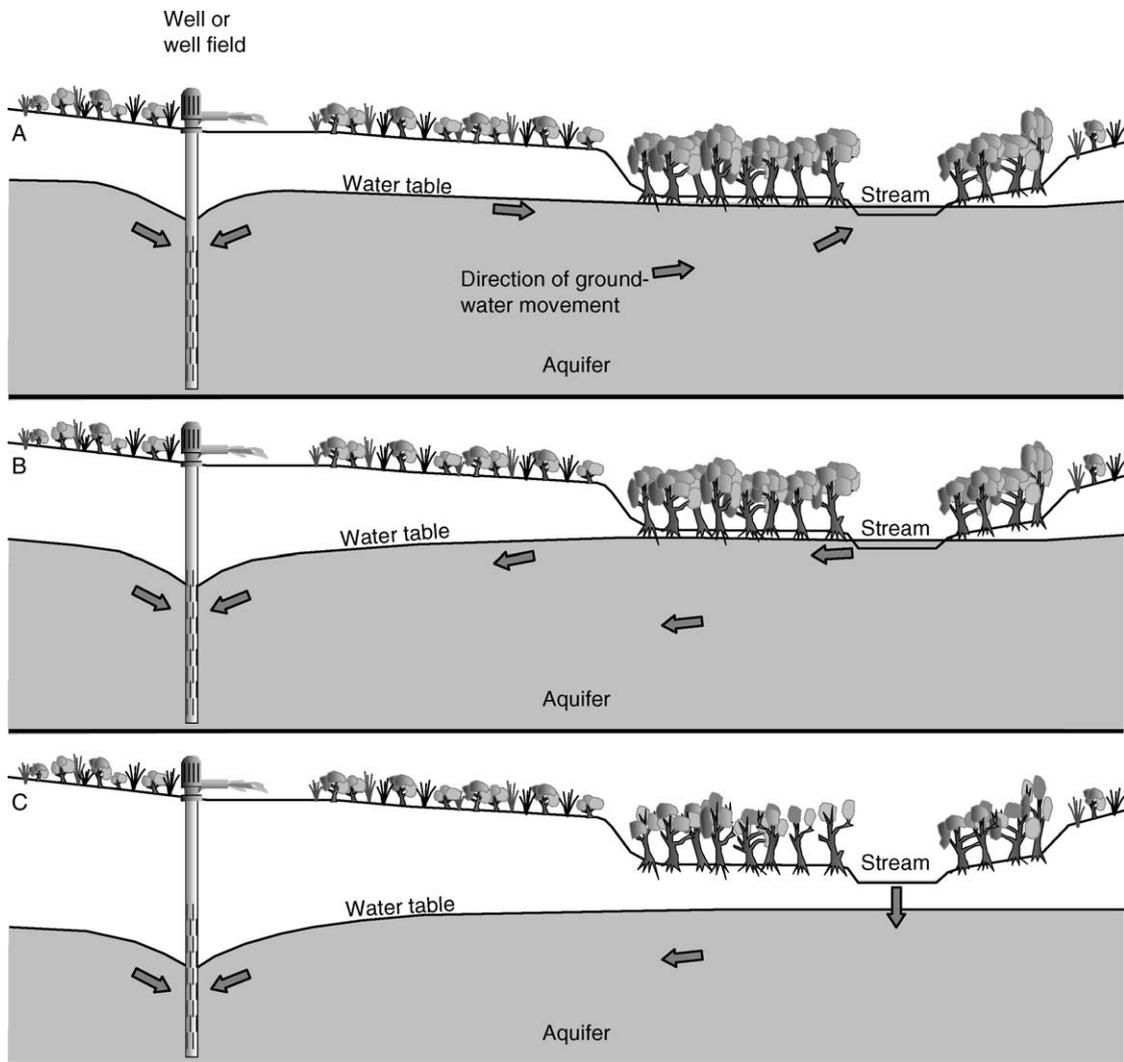
Fig. 4. Expected stages of capture of ground-water outflow to a riparian area and stream. (A) Stage I—near the onset of pumping, water pumped comes from storage around the well and the stream/aquifer system functions as it did prior to pumping. Ground water from upgradient areas supplies riparian vegetation in the floodplain as well as base flow to the gaining stream. Periodic stream runoff events also may supply water to the near-stream aquifer. (B) Stage II—drawdown from well has caused movement of water away from the stream and floodplain after a substantial period of pumping. Availability of water for riparian phreatophytes may not be diminished because of increased inflow from the stream, but the stream has become losing or possibly intermittent. (C) Stage III—after a substantial period of pumping in excess of rate of ground-water flow from upgradient areas, the stream and aquifer may be disconnected if streamflow cannot provide enough recharge to maintain the water table. The stream has become ephemeral.

As illustrated in Fig. 4, the effects of ground-water pumping of an alluvial aquifer on a riparian system can be categorized into three stages. Stage I begins with the cone of depression that develops at the onset of pumping, locally affecting water stored around

the well and not significantly impacting the reach-scale stream/aquifer system. Stage II begins after a substantial withdrawal draws down the aquifer sufficiently to create a water-level gradient away from the stream and floodplain; water availability to riparian plants may be unaffected but streamflow may be reduced. Finally, after a substantial period of pumping in excess of rate of ground-water flow from up-gradient areas, surface-water and ground-water systems may become disconnected if streamflow cannot provide enough recharge to maintain water levels in the alluvial aquifer. In Stage III, riparian vegetation can be strongly affected.

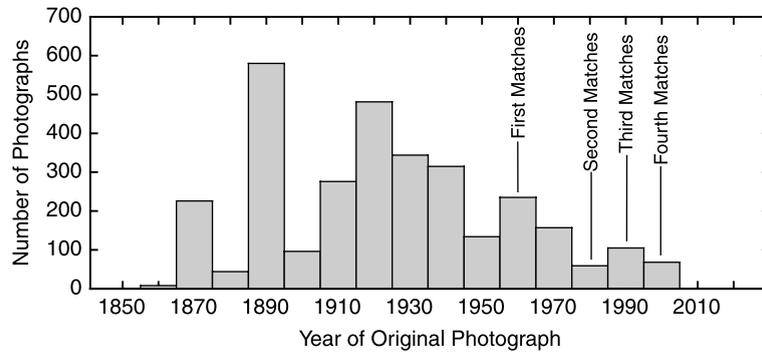
Fig. 5. Histogram showing the temporal distribution of the original dates of historical photography used to document long-term change in riparian vegetation in the Southwest.

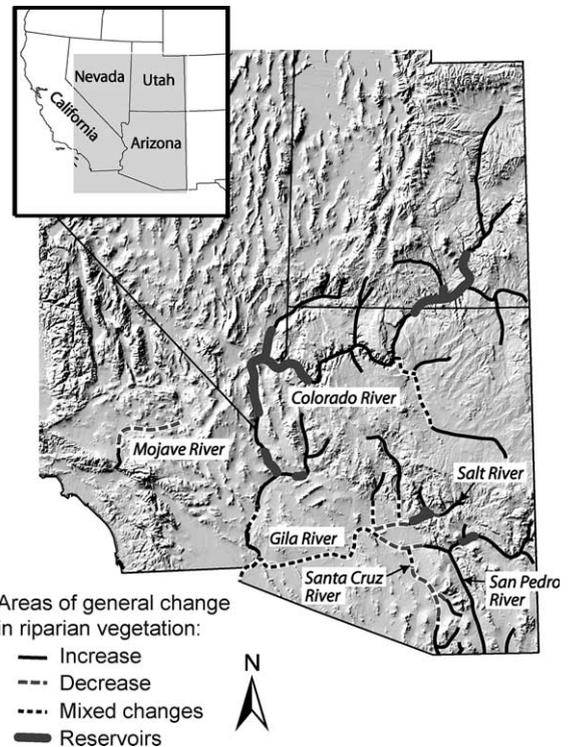
Fig. 6. Digital-elevation topographic map of the southwestern United States showing principal watercourses and reach-averaged change in riparian vegetation.

The repeat photography (Table 1) shows that virtually all riparian areas in the Southwest have changed owing to natural and human causes (Fig. 6). All free-flowing river reaches documented in southern Utah and northern Arizona have had increases in riparian vegetation in the 20th century, most notably

Beginning at the delta of Lake Powell in Cataract Canyon, the Colorado River represents a mosaic of changing riparian vegetation to the United States—Mexican border (Fig. 6). Bedrock-controlled reaches where stage-discharge relations show a wide range in pre-dam inundation had little riparian vegetation. Locally, terraces in Glen Canyon, wide reaches of Grand Canyon, in the wider reaches now covered by Lake Mead, in Cottonwood Canyon, and near present-day Lake Havasu City supported riparian stands that ranged from mesquite thickets to open cottonwood

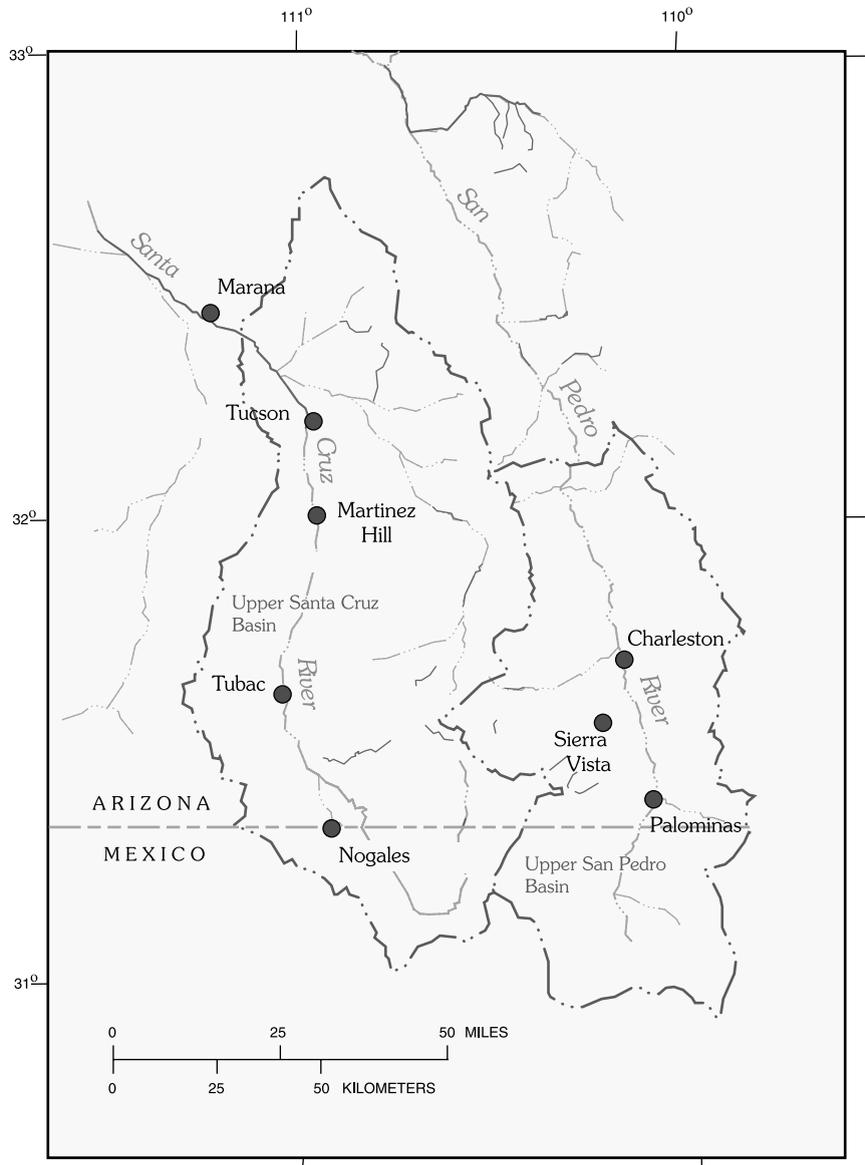
Fig. 7. Map of the San Pedro and Santa Cruz watersheds in southern Arizona and Sonora, Mexico.

The San Pedro River enters the United States from its headwaters in Sonora, Mexico (Fig. 7). Beginning upstream from Palominas, Arizona, the river is effluent and supports a closed gallery forest of cottonwood flanked with mesquite on the distal margins of flood plains. Ground-water levels in the alluvial aquifer are high and fluctuate, probably in response to recharge from floods (Fig. 8A). At Charleston, annual flow is $1.59 \text{ m}^3/\text{s}$ (Table 2) and the annual flood series consists of an extremely large flood in 1926 ($2780 \text{ m}^3/\text{s}$) followed by a series of relatively small floods extending to 2001; at Palominas (Fig. 8B), annual flow is $0.86 \text{ m}^3/\text{s}$, and the flood record is similar although streamflow gaging began after the 1926 event. Ground-water development near the river has not significantly reduced levels in the alluvial aquifer (Fig. 8A), although ground-water development in and adjacent to Sierra Vista, Arizona (Fig. 7), is thought to pose a severe future threat to the riparian ecosystem (Pool and Coes, 1999). A total of 59 historical

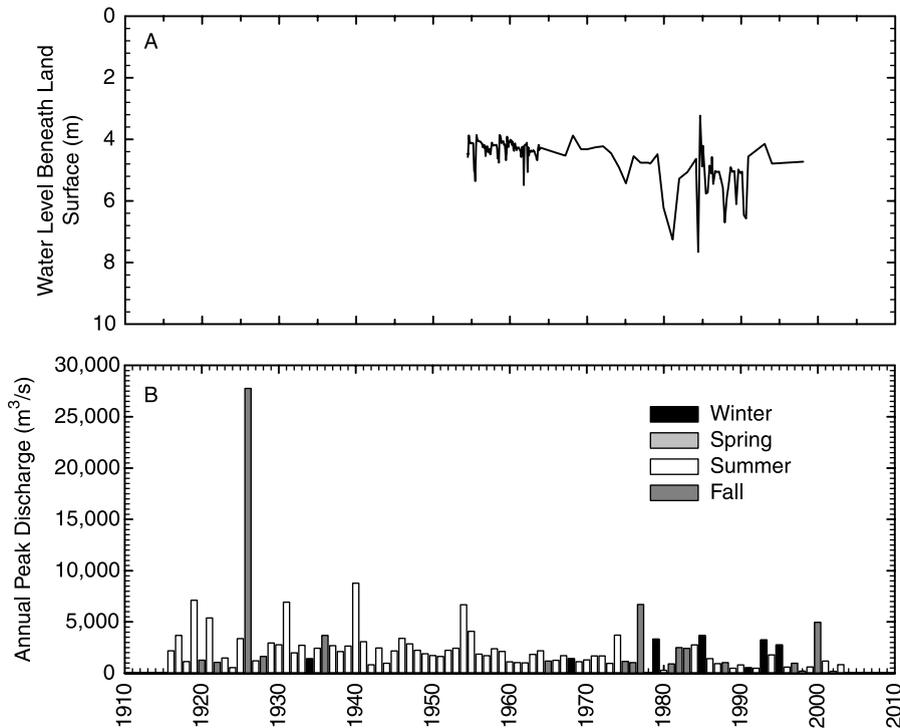
Fig. 8. Annual flood series and ground-water levels for the upper San Pedro River. (A) Ground-water levels for well D-23-22 33DCD2 adjacent to the San Pedro River near Palominas, Arizona. (B) Annual flood series for the San Pedro River at Palominas, Arizona (09470500). These two graphs show stationary records of surface water and ground water, which indicates riparian vegetation should benefit from the stable hydrologic conditions along this river.

1892 (Bryan, 1925). Widening ensued, with the overall geometry of the arroyo stabilizing by 1941 (Hereford, 1993). The first photographs, taken in the 1930 s, show a barren channel with no stable flood plains within the arroyo walls (Fig. 9A). After 1941, low flood plains developed (Hereford, 1993) owing to a summer-dominated flood regime (Fig. 8B), allowing establishment of mostly native woody species (Fig. 9B). Beginning in the mid-1960 s, the seasonality of flooding shifted to a fall- and winter-dominated pattern (Fig. 8B). Woody riparian

Ground-water levels remain high near Palominas despite fluctuations (Fig. 8A) that may be attributable to agricultural operations, which increased in the 1970 s and 1980 s. Base-flow decreases in this period (Pool and Coes, 1999) could be explained individually or collectively by a variety of factors. Ground-water and surface-water development associated with mining operations in Mexico and agricultural and urban development in the United States could be affecting the overall aquifer system that creates effluent conditions in this reach, as suggested in Fig. 4. The large increase in riparian vegetation could, through evapotranspiration, be reducing surface flows. Finally, seasonal shifts in regional climate (Turner et al., 2003), combined with increased woody vegetation on uplands, could be reducing recharge to the alluvial aquifer.

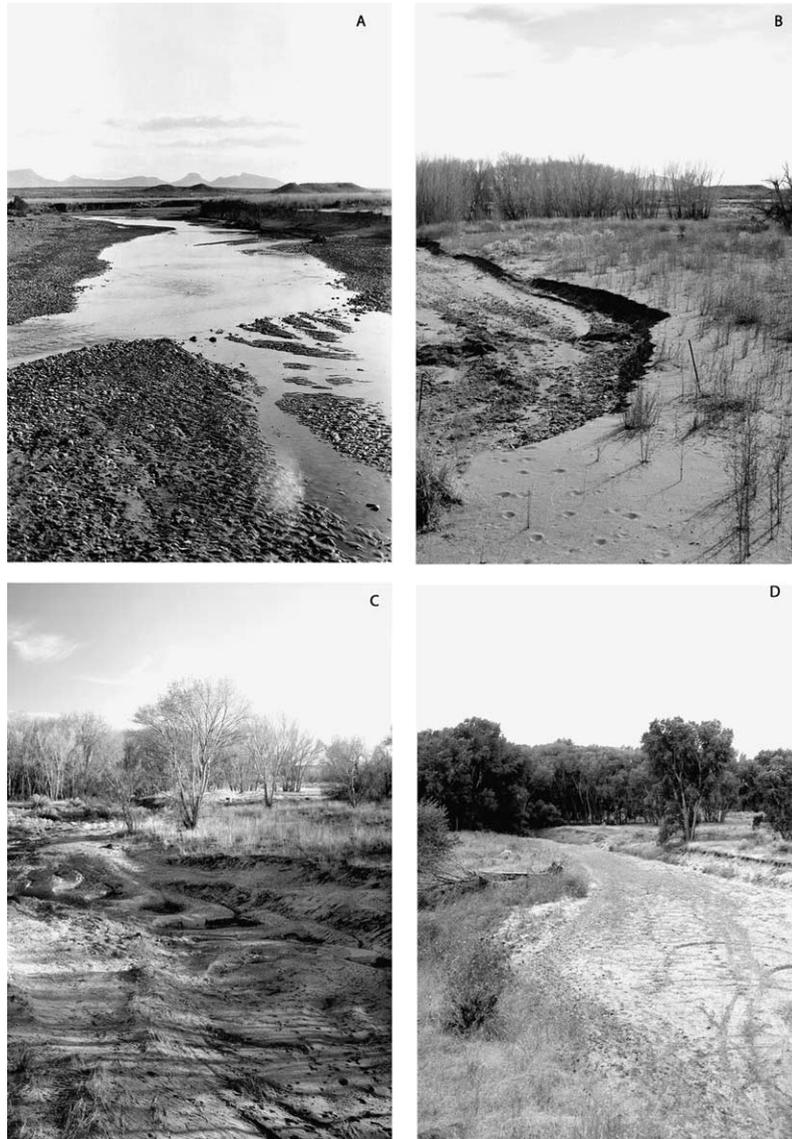
Fig. 9. Repeat photography showing changes in riparian vegetation along the San Pedro River at Palominas, Arizona. (A) (April 17, 1930). This upstream view on the San Pedro River shows a wide arroyo system without flow terraces. An extremely large flood occurred in 1926, only four years before this photograph was taken. The mountains in the distance are in Sonora, Mexico. The terraces support desert scrub, although they once likely supported alkali sacaton grassland on marshy flood plains (Turner et al., 2003). A single juniper at left is the only significant woody species present (photographer unknown, courtesy of the U.S. Geological Survey). (B) (January 23, 1981). The channel had widened further in the mid-20th century, followed by the deposition of low terraces within the arroyo. A young cottonwood grove is shown in the background along the perennial stream (R.M. Turner). (C) (February 7, 1995). The cottonwoods have grown, and more have become established in the intervening 14 years. The low terrace, now a flood plain within the larger channel, has become more prominent. (D. Oldershaw). (D) (October 8, 2000). Cottonwood establishment and growth continued in the intervening 5 years, forming a closed canopy forest obscuring the background. Another photograph taken 6 weeks later shows little change despite the occurrence of the largest flood since 1978 and the third largest in the 65-year gaging record (Fig. 8B). (D. Oldershaw, Stake 1007).

vegetation increased despite periodic, sizeable floods (Fig. 9B–D). Tamarisk is present in this reach but is diminutive and sparse under the closed canopy of native species.

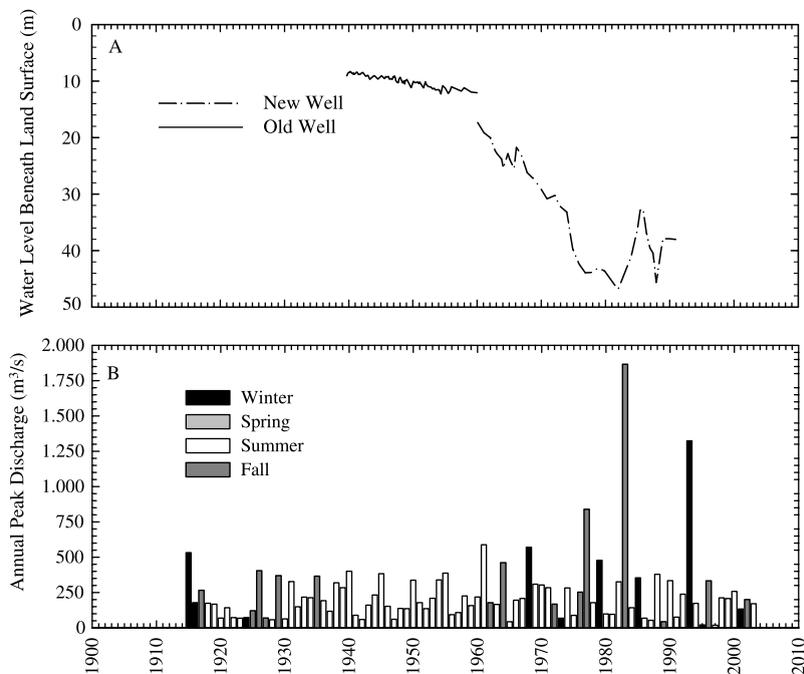
Fig. 10. Ground-water levels and annual flood series for the Santa Cruz River. (A) Ground-water levels for two wells—D-15-13 22DCC2 (old well) and D-15-13 23CCB2 (new well)—along the Santa Cruz River north of Martinez Hill near Tucson, Arizona. Excessive withdrawals are responsible for water-level declines after about 1950, and rises in the early 1980 s and early 1990 s reflect recharge during large floods. (B) Annual flood series of the Santa Cruz River at Tucson, Arizona (09482500).

Beginning with the 1977 event, and extending through 1993, a series of fall and winter floods widened the channel to its current extent (Fig. 11B). As shown in Fig. 10B and discussed by Webb and Betancourt (1992), these events represent a change in seasonality of flooding as well as suggest that the flood history is non-stationary. The San Pedro River also had seasonality change but did not have the increased flood frequency (Fig. 8B). These floods also

temporarily recharged the aquifer immediately underneath the river (Fig. 10A), as depicted by a 12.2 m rise in water level following the 1983 flood. This increase was temporary and not sufficient to sustain growth of new riparian vegetation.

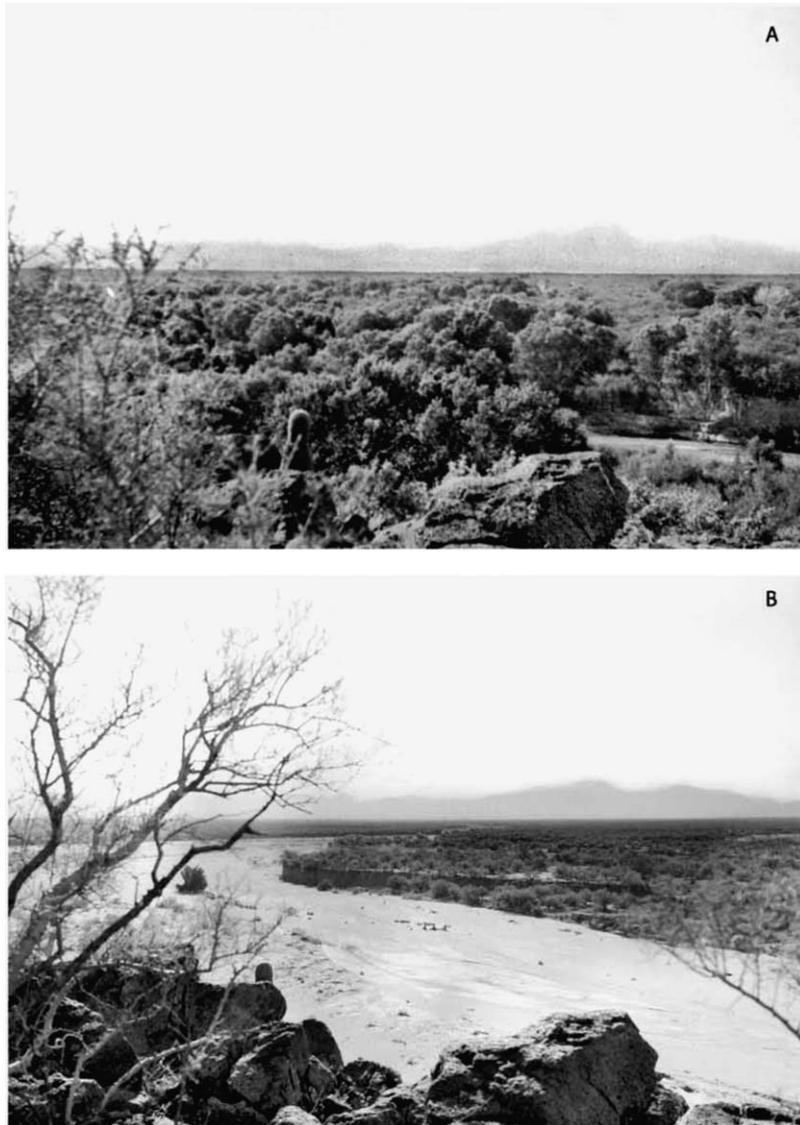
Fig. 11. Repeat photography showing changes in riparian vegetation along the Santa Cruz River south of Martinez Hill. (A) (June 1942). Perennial flow in the Santa Cruz River in the vicinity of Martinez Hill prompted Spanish missionaries to establish the Mission San Xavier del Bac near this site in the early 1700 s. By 1940, a narrow arroyo had formed here, but the riparian ecosystem continued to thrive. Cottonwoods line the channel, visible at lower right, with an extensive mesquite bosque in the background. (photographer unknown, courtesy of the Arizona Game and Fish Department). (B) (November 25, 2002). By the time of the first repeat photograph from this camera station in 1981, the cottonwoods had disappeared and the mesquite bosque was dying. The 1977, 1983, and 1993 floods (Fig. 10B) widened the channel significantly, removing low floodplains. Ground-water overdraft had dropped water levels in the alluvial aquifer well beyond the roots of riparian species (R.M. Turner, Stake 937).
